GEnx-1B SERVICE BULLETIN - 73-0097 R01

SB 73-0097 R01 ENGINE FUEL AND CONTROL - ELECTRONIC ENGINE CONTROL
 Issued:

(73-21-20) - REPLACEMENT OF INTEGRATED CIRCUIT MN4 ON MAIN CHANNEL BOARDS
 12/17/2020

TO:	Holders of ENGINE FUEL AND CONTROL-FADEC3 GEnx-1B Electronic Control Unit (ECU).
FROM:	FADEC International CAGE: 3E6E4 11-13 Rue Ampere
	91344 MASSY - FRANCE Web: http://fadecinternational.net
SUBJECT:	FADEC3-73-092, ENGINE FUEL AND CONTROL - ECU Modification - Replacement of MN4 BGA microprocessor on Main Channel Boards (MCB), Revision 0, dated Dec 17/2020.

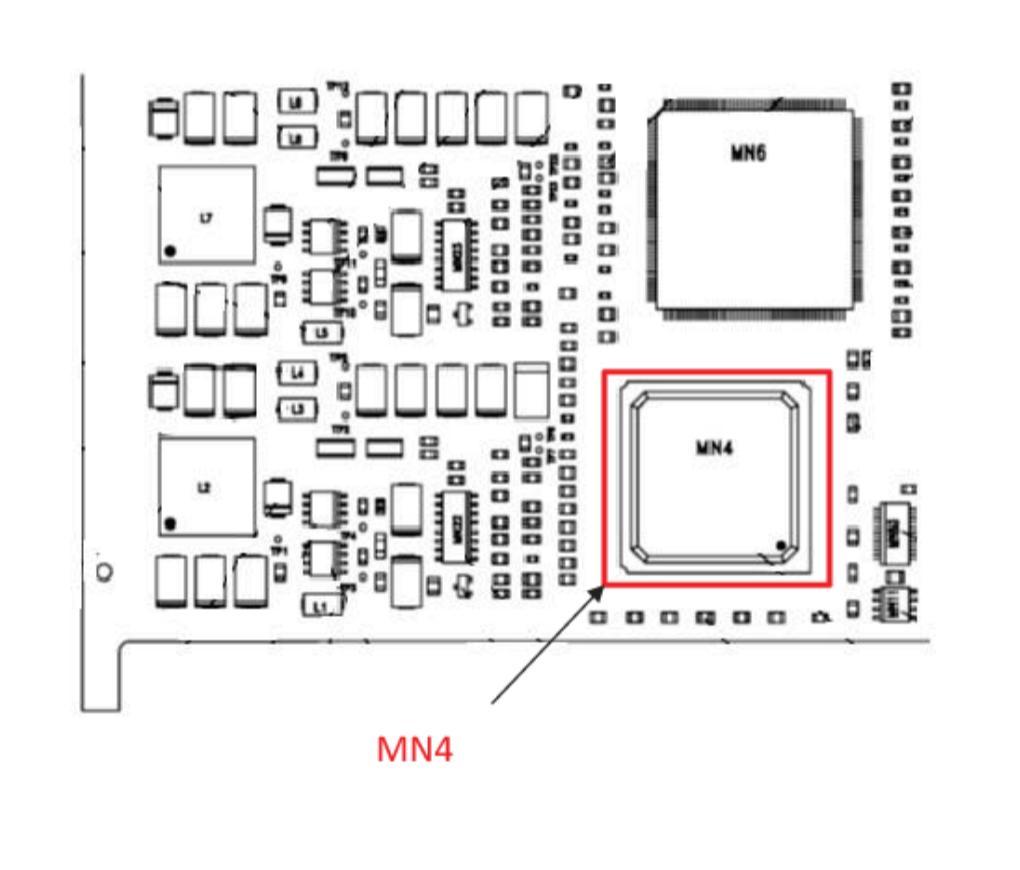
Location of MN4 Figure 1

A solder ball failure on the Integrated Circuit (MN4) on the MCB could initiate a system effect that may result in a LOTC.

Aging of BGA (Ball Grid Array) solder balls degraded the integrity of the solder connection.

The Integrated Circuit (MN4) on the MCB will be removed along with the solder and will be replaced with new solder and a new BGA.

(2) Remove and replace Integrated circuit MN4 (P/N 620-076-017-0). (Refer to Figure 1). This repair will be performed using the following internal FADEC International procedures:
