GEnx-1B SERVICE BULLETIN - 73-0097 R01

SB 73-0097 R01 ENGINE FUEL AND CONTROL - ELECTRONIC ENGINE CONTROL
 Issued:

(73-21-20) - REPLACEMENT OF INTEGRATED CIRCUIT MN4 ON MAIN CHANNEL BOARDS
 12/17/2020

TO:	Holders of ENGINE FUEL AND CONTROL-FADEC3 GEnx-1B Electronic Control Unit (ECU).
FROM:	FADEC International CAGE: 3E6E4 11-13 Rue Ampere
	91344 MASSY - FRANCE Web: http://fadecinternational.net
SUBJECT:	FADEC3-73-092, ENGINE FUEL AND CONTROL - ECU Modification - Replacement of MN4 BGA microprocessor on Main Channel Boards (MCB), Revision 0, dated Dec 17/2020.

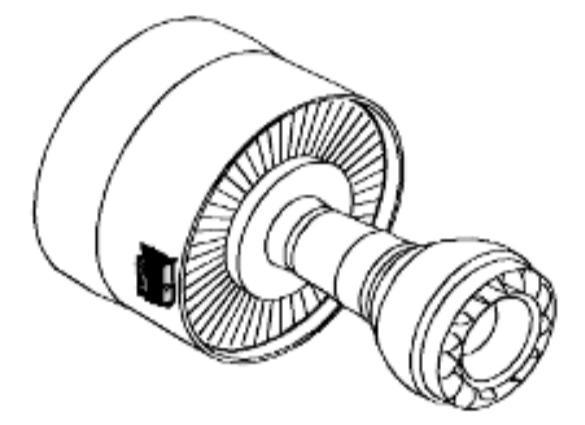
EEC Location Figure 1

- (1) Remove the EEC (Figure 1). Removal instructions have not changed. Refer to the GEnx-1B EM, 72-00-00, DISASSEMBLY 001 or GEnx-1B Boeing 787 AMM, G73-21-05, ELECTRONIC ENGINE CONTROL - REMOVAL, B787-A-G73-21-05-00A-520A-A.
- (2) Send the removed EEC (Figure 1) to FADEC International. Refer to the attached FADEC International Service Bulletin FADEC3/73-092 (latest version).
- (3) Install the EEC (Figure 1). Installation instructions have not changed. Refer to the GEnx-1B EM, 72-00-00, ASSEMBLY 001 or GEnx-1B Boeing 787 AMM, G73-21-05, ELECTRONIC ENGINE CONTROL - INSTALLATION, B787-A-G73-21-05-00A-720A-A.
